DEVELOPMENT OF IMPROVED LACV-30 PROPELLER BLADE COATINGS  
FOR PROTECTION AGAINST SAND AND RAIN EROSION AND MARINE  
ENVIRONMENT CORROSION

Glenn A. Malone  
Bell Aerospace Textron  
Post Office Box 1  
Buffalo, New York 14240

10 May 1983

Final Report for period 4 January 1982 - 4 March 1983

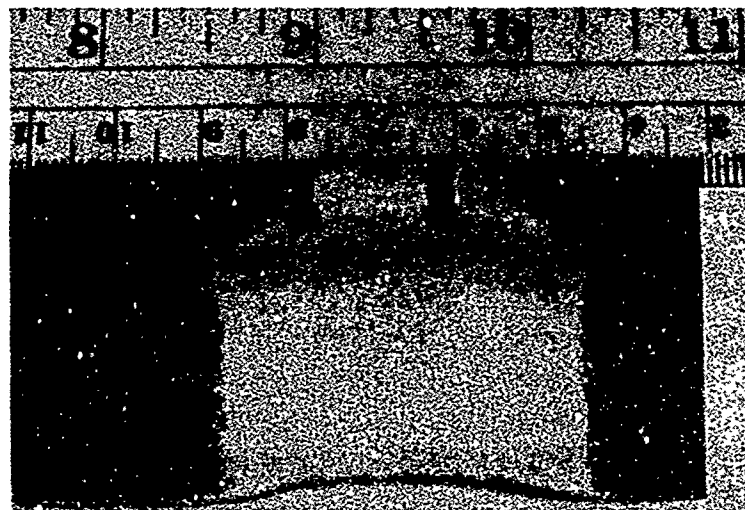
Figure 54. Duranodic Anodized (0.06 mm) + Sandstrom LC-300  
Specimen after Exposure for 60 Minutes at 274.3 m/sec (900  
ft/sec) to Sand Environment; Sand Flow 908 g/min (2 lb/min)

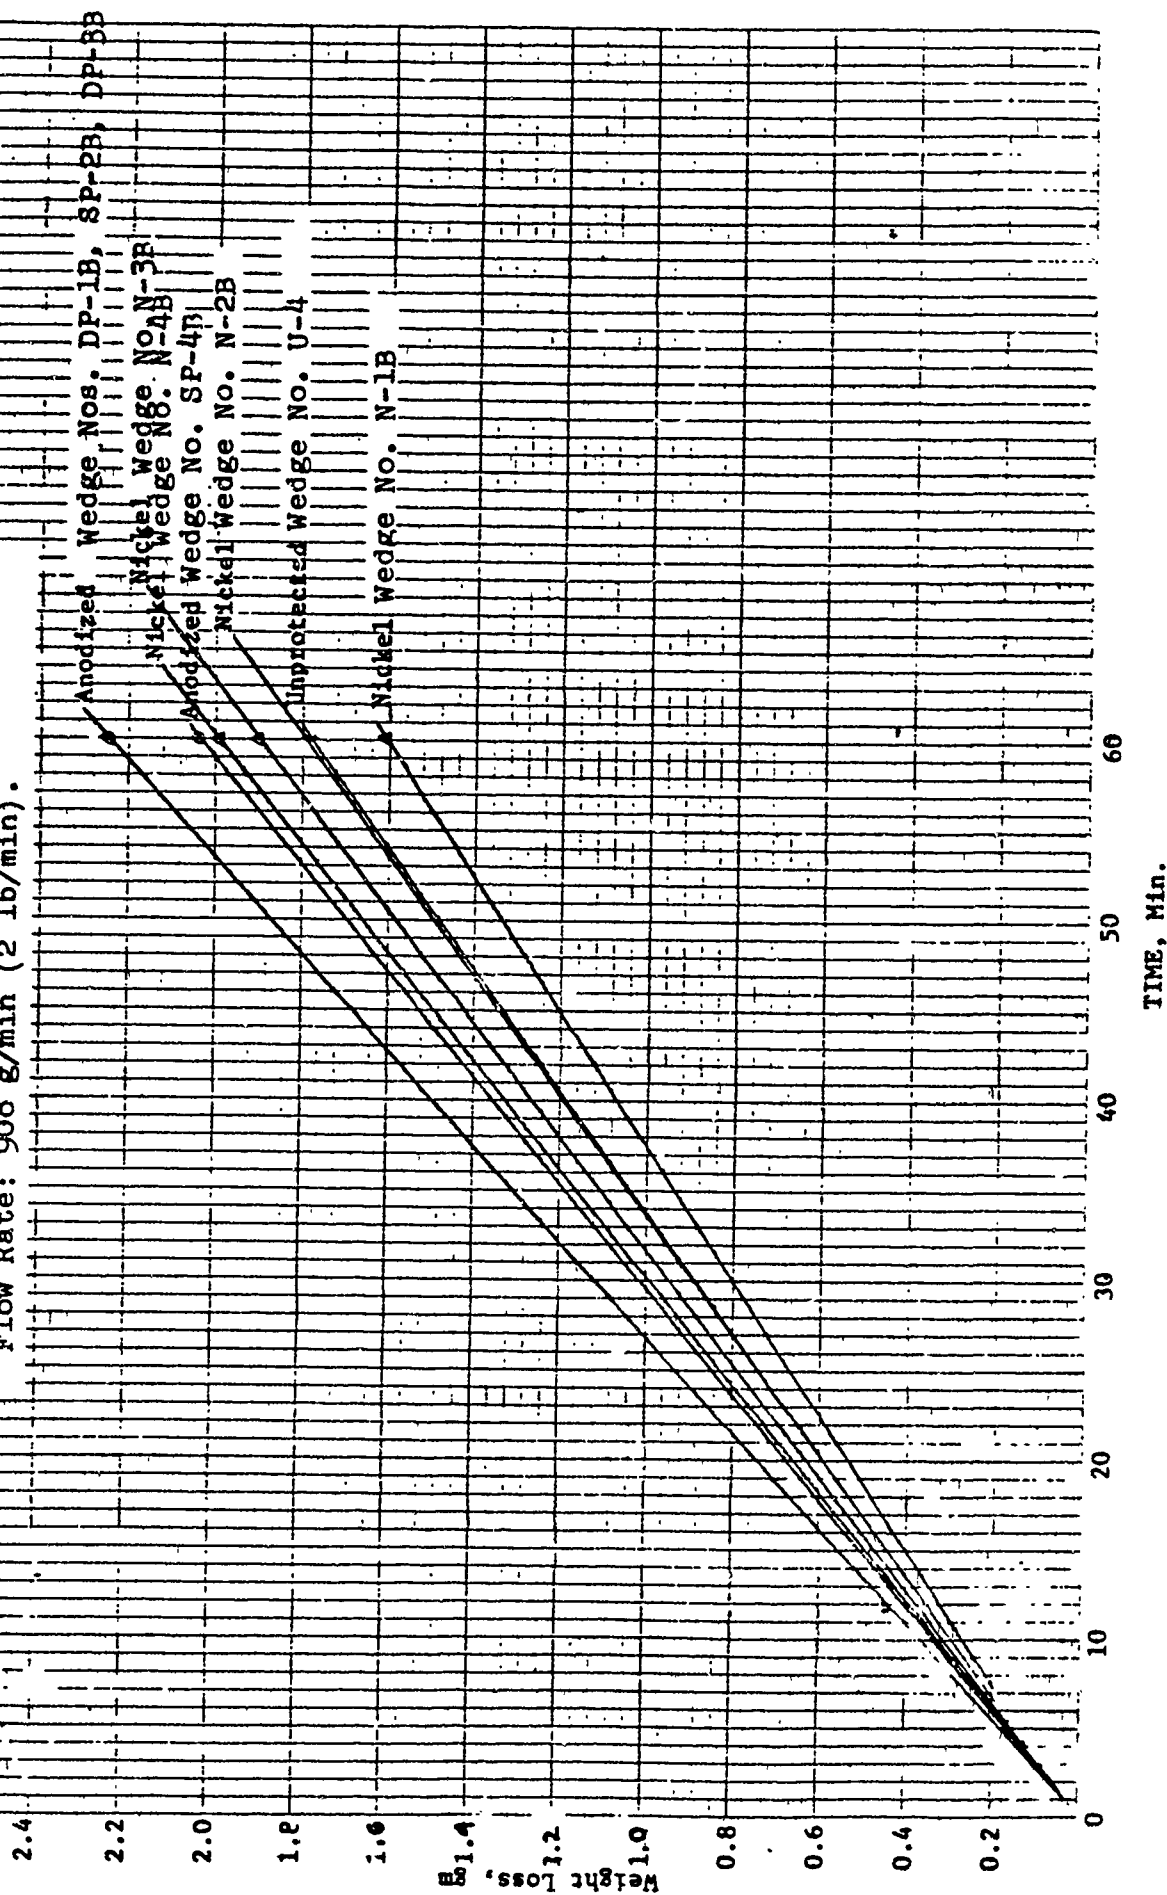
Figure 61. Volume Loss Vs. Exposure Time, Unprotected, Anodized, and Hard Nickel Plated Specimens Exposed at 274.3 m/sec (900 ft/sec) in Sand Environment. Sand Flow Rate: 908 g/min (2 lb/min).
